**Tree Inventory and Preservation Plan
7525 Garner Road
Niagara Falls, Ontario**

29 October 2024; revised 25 July 2025

KUNTZ FORESTRY CONSULTING INC. Project P4195

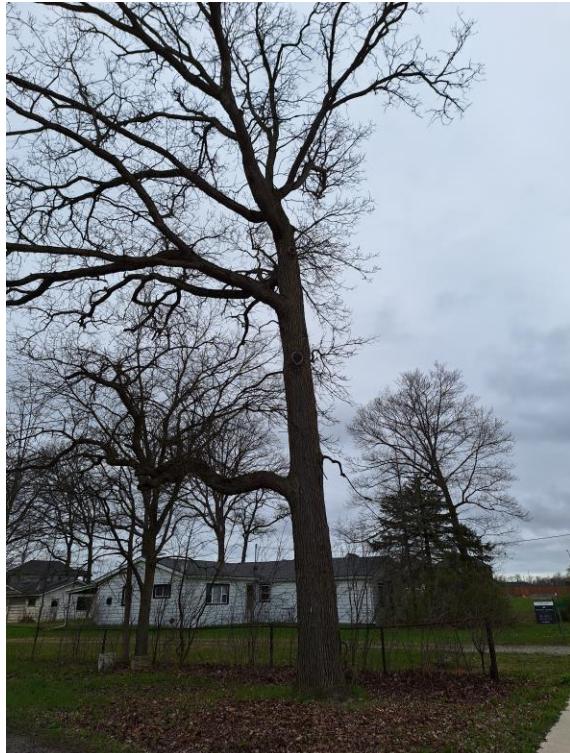
Image 1. Tree 813

Tree #	Common Name	Scientific Name	DBH	TI	CS	CV	CDB	DL	Comments	Ownership	Action
813	Swamp White Oak	<i>Quercus bicolor</i>	77	F	F	F		10	Asymmetrical crown (M), pruning wounds (M), lean (L), epicormic branching (L)	Subject	Remove
814	Swamp White Oak	<i>Quercus bicolor</i>	37.5	F	PF	PF		3	Pruning wounds (H), asymmetrical crown (M), poor form (M), epicormic branching (M)	Shared (Subject / City)	Remove
815	Swamp White Oak	<i>Quercus bicolor</i>	67	FG	PF	PF	40	7	Pruning wounds (L), epicormic branching (M)	Subject	Remove
816	Swamp White Oak	<i>Quercus bicolor</i>	59.5	F	PF	PF	40	7	Pruning wounds (M), asymmetrical crown (M), epicormic branching (M)	Subject	Remove
817	Red Oak	<i>Quercus rubra</i>	~50, 42	F	PF	PF		5	V-union at 1m with included bark, epicormic branching (H), pruning wounds (L), stems fused from union to 2m	Shared (Subject / City)	Remove
818	Swamp White Oak	<i>Quercus bicolor</i>	38	D	D	D	100	-		Shared (Subject / City)	Remove

The removal of 16 trees and three polygons will be required to accommodate the proposed development. The required tree and polygon removals include Trees 813 – 828 and Polygons P-1 – P-3. The trees and polygons identified for removal directly either conflict directly with the proposed development or the level of encroachment into their driplines resulting from the proposed work would be at an intolerable level such that we would not expect the trees to overcome the injury.

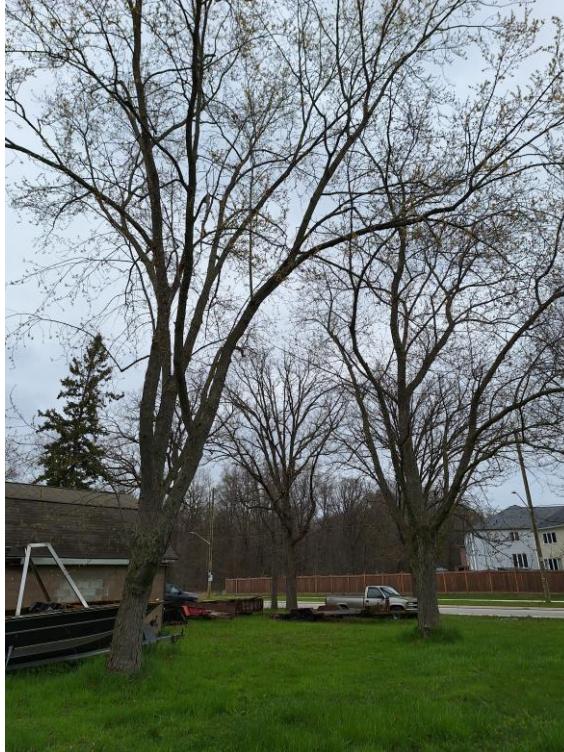
Image 5. Trees 819 (right) and 820 (left)

819	Silver Maple	<i>Acer saccharinum</i>	61	G	FG	F	10	7		Subject	Remove
820	Silver Maple	<i>Acer saccharinum</i>	52.5	G	F	F		7	Broken branches (L), asymmetrical crown (L)	Subject	Remove
821	Silver Maple	<i>Acer saccharinum</i>	64.5	PF	F	F		8	Bow (M), cavities (L), epicormic branching (L), poor branch unions	Subject	Remove
822	Silver Maple	<i>Acer saccharinum</i>	68.5	FG	F	F		7	Asymmetrical crown (M), epicormic branching (L), poor branch unions	Subject	Remove
823	Silver Maple	<i>Acer saccharinum</i>	44	F	F	F		7	Lean (L), epicormic branching (M), asymmetrical crown (L), bow (L)	Subject	Remove
824	Silver Maple	<i>Acer saccharinum</i>	34.5	F	PF	F	20	6	Lean (L), cavities (L), broken branches (M), epicormic branching (L)	Subject	Remove
825	Silver Maple	<i>Acer saccharinum</i>	43, 39	PF	PF	PF	20	7	Union at base, lean (M), cavities (L), epicormic branching (H), crook (M)	Subject	Remove
826	White Ash	<i>Fraxinus pennsylvanica</i>	11	F	G	FG		2	Bow (L), Emerald Ash Borer (L)	Subject	Remove

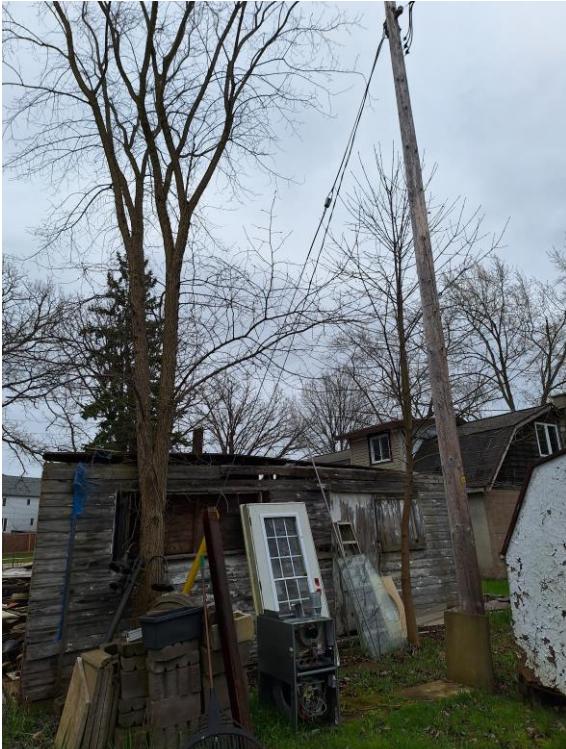
Image 8. Trees 826 (left) and 827 (right)

827	White Elm	<i>Ulmus americana</i>	27	F	F	F		4	V-union at 2m with included bark, epicormic branching (M)	Subject	Remove
828	White Spruce	<i>Picea glauca</i>	33	FG	G	FG		3	Lean (L)	Subject	Remove
A	Silver Maple	<i>Acer saccharinum</i>	~26, 24, 22	F	F	F		5	V-union at 0.5m and 1m with included bark, lean (L), epicormic branching (L)	Neighbour	Preserve
B	Silver Maple	<i>Acer saccharinum</i>	~50	F	F	F		5	V-union at 1m with included bark, asymmetrical crown (M)	Neighbour	Preserve
C	Silver Maple	<i>Acer saccharinum</i>	~30	G	G	FG		4		Neighbour	Preserve
D	Silver Maple	<i>Acer saccharinum</i>	~14, 12, 12	F	PF	PF	40	4	V-union at base and 0.5m with included bark, vine competition (L), broken branches (L)	Neighbour	Preserve
E	Silver Maple	<i>Acer saccharinum</i>	~26	F	FG	FG		4	V-union in crown with included bark	Neighbour	Preserve
F	Silver Maple	<i>Acer saccharinum</i>	~26, 12	PF	P	PF	40	4	V-union at base with included bark, spiralling stems, poor form (M), poor branch unions	Neighbour	Preserve

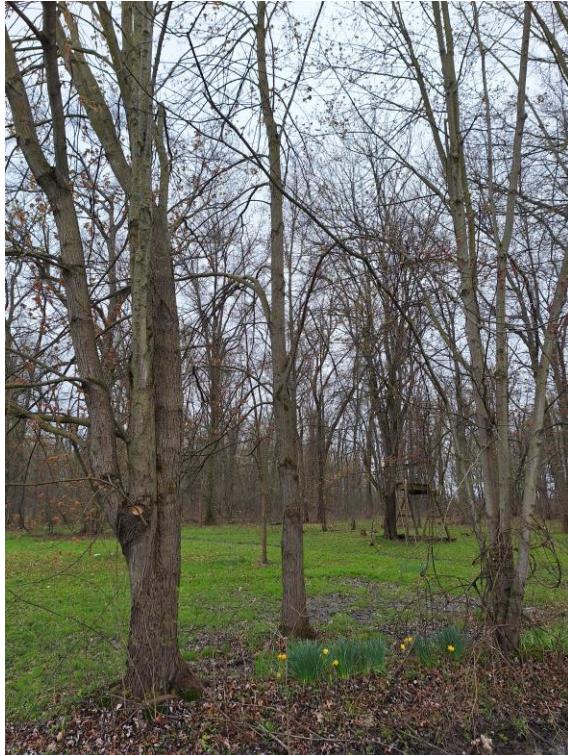
Image 11. From left to right, Trees B – D

Tree preservation fencing has been prescribed at the driplines of the trees identified for preservation, where possible. Although the entire driplines cannot be respected for Trees B and D, these trees are afforded minimum tree protection zones (mTPZs) that are consistent with standards utilized by surrounding municipalities.

Tree B can be provided with at least 3.0m of protection and Tree D can be provided with at least 1.8m of protection. This level of protection is expected to be sufficient in protecting these trees throughout the proposed works.

The preservation of the remaining nine trees will be possible with the use of appropriate tree protection measures as indicated on Figure 1. The trees designated for preservation include Trees A – I. Tree protection measures must be implemented prior to the commencement of the proposed works to ensure tree resources designated for preservation are not impacted.

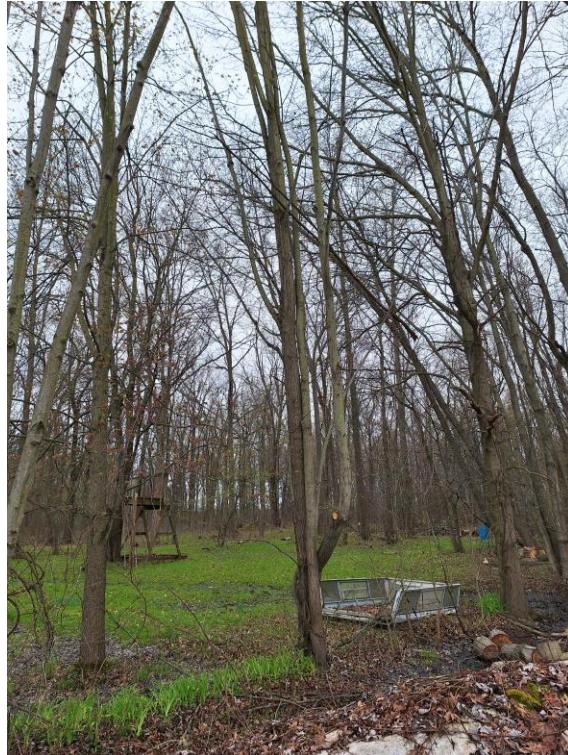
Image 12. From left to right, Trees E – G

G	Red Oak	<i>Quercus rubra</i>	~36	G	P	PF	40	5	Broken branches (M)	Neighbour	Preserve
H	Silver Maple	<i>Acer saccharinum</i>	~42	FG	FG	FG		6	Bow (L), epicormic branching (L)	Neighbour	Preserve
I	White Ash	<i>Fraxinus pennsylvanica</i>	~18, 16	D	D	D	100	-	V-union at 0.2m with included bark, Emerald Ash Borer (H)	Neighbour	Preserve
P-1									See Table 2	Subject	Remove

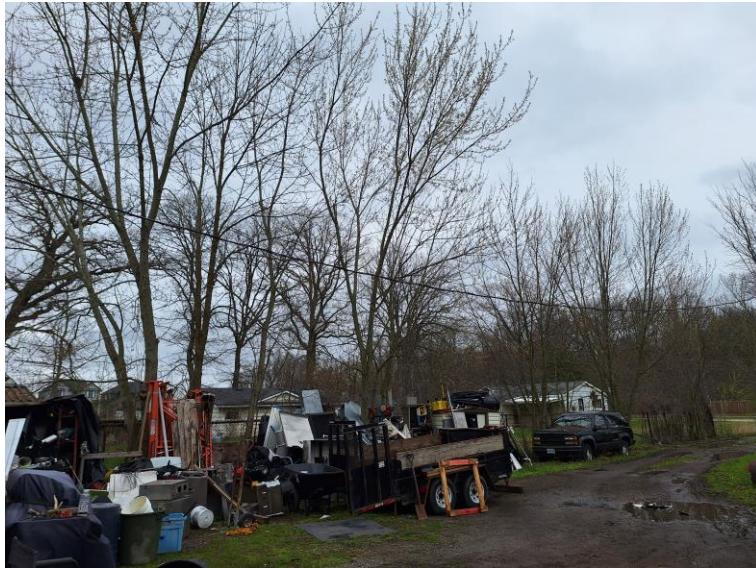
Image 15. Polygon P-2

Tree Size Class →	10cm - 19.5cm		20cm - 30cm		30.5cm - 40cm		40.5cm - 50cm		50.5cm +		Total All Sizes	
Species	AGS	UGS	AGS	UGS	AGS	UGS	AGS	UGS	AGS	UGS	AGS	UGS
White Elm (<i>Ulmus americana</i>)	0	1	0	0	1	0	0	0	0	0	1	1
White Ash (<i>Fraxinus americana</i>)	0	6	0	0	0	0	0	0	0	0	0	6
Silver Maple (<i>Acer saccharinum</i>)	2	1	2	2	0	0	0	0	0	0	4	3
Total Number of Trees	2	8	2	2	1	0	0	0	0	0	5	10

Polygon P-2 is located partially on a neighbouring property and as such, written permission from the respective neighbouring property owner will be required prior to the removal of this polygon. Trees 814, 817, and 818 are located partially within the Garner Road right-of-way and as such, permission from the City of Niagara Falls will be required prior to the removal of these trees. All other trees and polygons identified for removal are located fully within the boundaries of the subject property.
