Re: Wetland Water Balance, 7525 Garner Road, Niagara Falls, ON

### **1.0 Introduction, Background Information and Purpose**

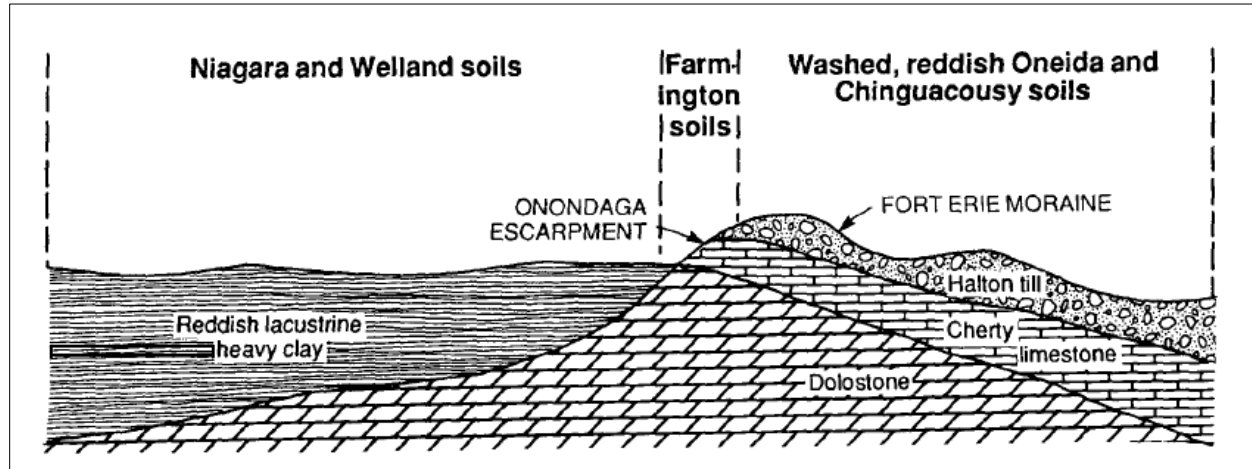
Figure 5 – Schematic landscape cross-section showing the Niagara and Welland soils (Kingston and Presant, 1989)

The OMAFRA mapped soils for the Site, including the on-site portion of the Provincially Significant Wetland (PSW), are mapped as a combination of Niagara-Loamy Phase and Welland soils (Figure 5) (Appendix C). Soil details include the following (Kingston and Presant, 1989):

- i. Niagara- Loamy Phase – Imperfectly drained and moderate to slow permeability. These soils have high to moderate water-holding capacity and surface water runoff ranges from slow to high based on topography (Hydrological Soil Group (HSG) D, Table 1). These soils are often found as an inclusion within Welland Soils.
- ii. Welland- Poorly drained and relatively impermeable except in the summer when surface cracking increases. These soils have slow to moderate surface water runoff and a relatively high water-holding capacity (Hydrological Soil Group (HSG) D, Table 1).

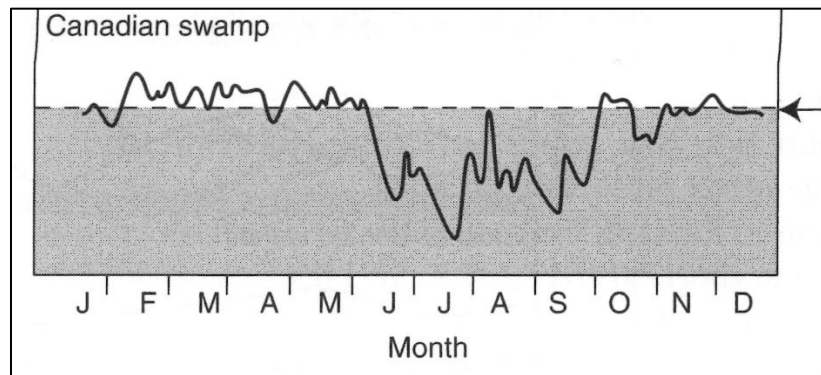
Figure 7 – Canadian Swamp Hydroperiod (Mitsch and Gosselink, 2007)

Note: arrow indicates wetland ground surface

Mitsch and Gosselink (2007) report that the "hydroperiods of many bottomland hardwood forests and swamps have distinct periods of surface flooding in the winter and early spring due to snow and ice conditions followed by spring floods but otherwise have a water table that can be a meter or more below the surface" (Figure 7). This characterization is considered reasonable for the PSW swamp in comparing the surface water level monitoring at SG-1 (Appendix B) to a published hydroperiod for a Canadian swamp given the precipitations conditions mentioned on Section 3.6.1 (Figure 7). The small area of the PSW on-site receives water from precipitation and potentially runoff via the adjacent

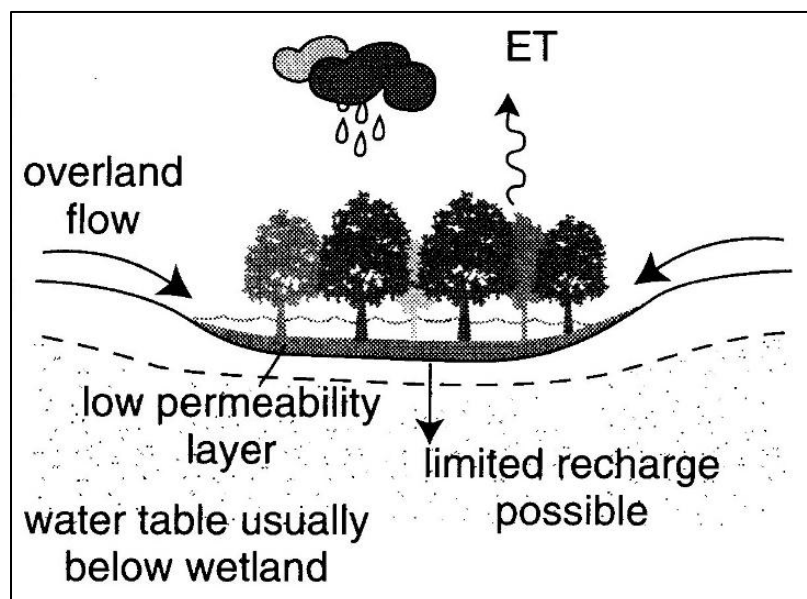
Figure 8 - Surface water depression and surface water slope wetlands (Mitsch and Gosselink, 2007)

The small portion of the swamp PSW that is within the western boundary of the property can be classified as a surface water depression wetland (Figure 8) (Mitsch and Gosselink, 2007).

A surface water depression wetland is summarized as a: *"wetland...dominated by surface runoff and precipitation, with little groundwater outflow due to a layer or low-permeability soils..."*. Low permeability soils have been noted beneath the Site (Section 3.5.1) and the wetland reasonably fit this description.

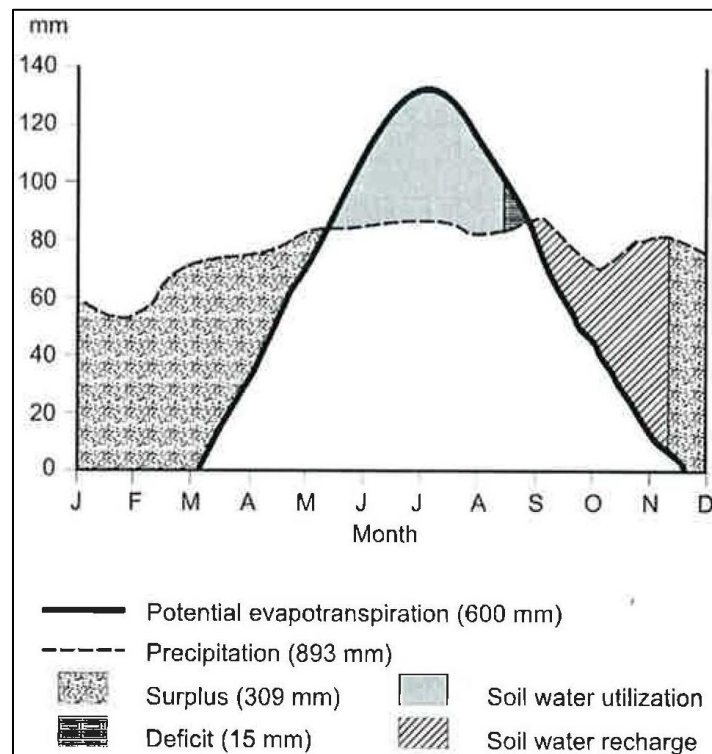
Figure 9 – Brantford Average Water Balance (Sanderson, 2004)

An example of water balance modelling from the University of Waterloo is shown below (Figure 9). Annual groundwater recharge begins in the fall following 'soil water utilization' and 'deficit' in the summer. Soil water utilization corresponds with evapotranspiration exceeding the precipitation supply. Annual groundwater recharge occurs during the same time period that groundwater levels rise. However, in this example it is noted that the soil water holding capacity (SWHC) modelled was only 100 mm compared to the higher SWHC 400/350 mm for the swamp wetland (Section 3.6.4).

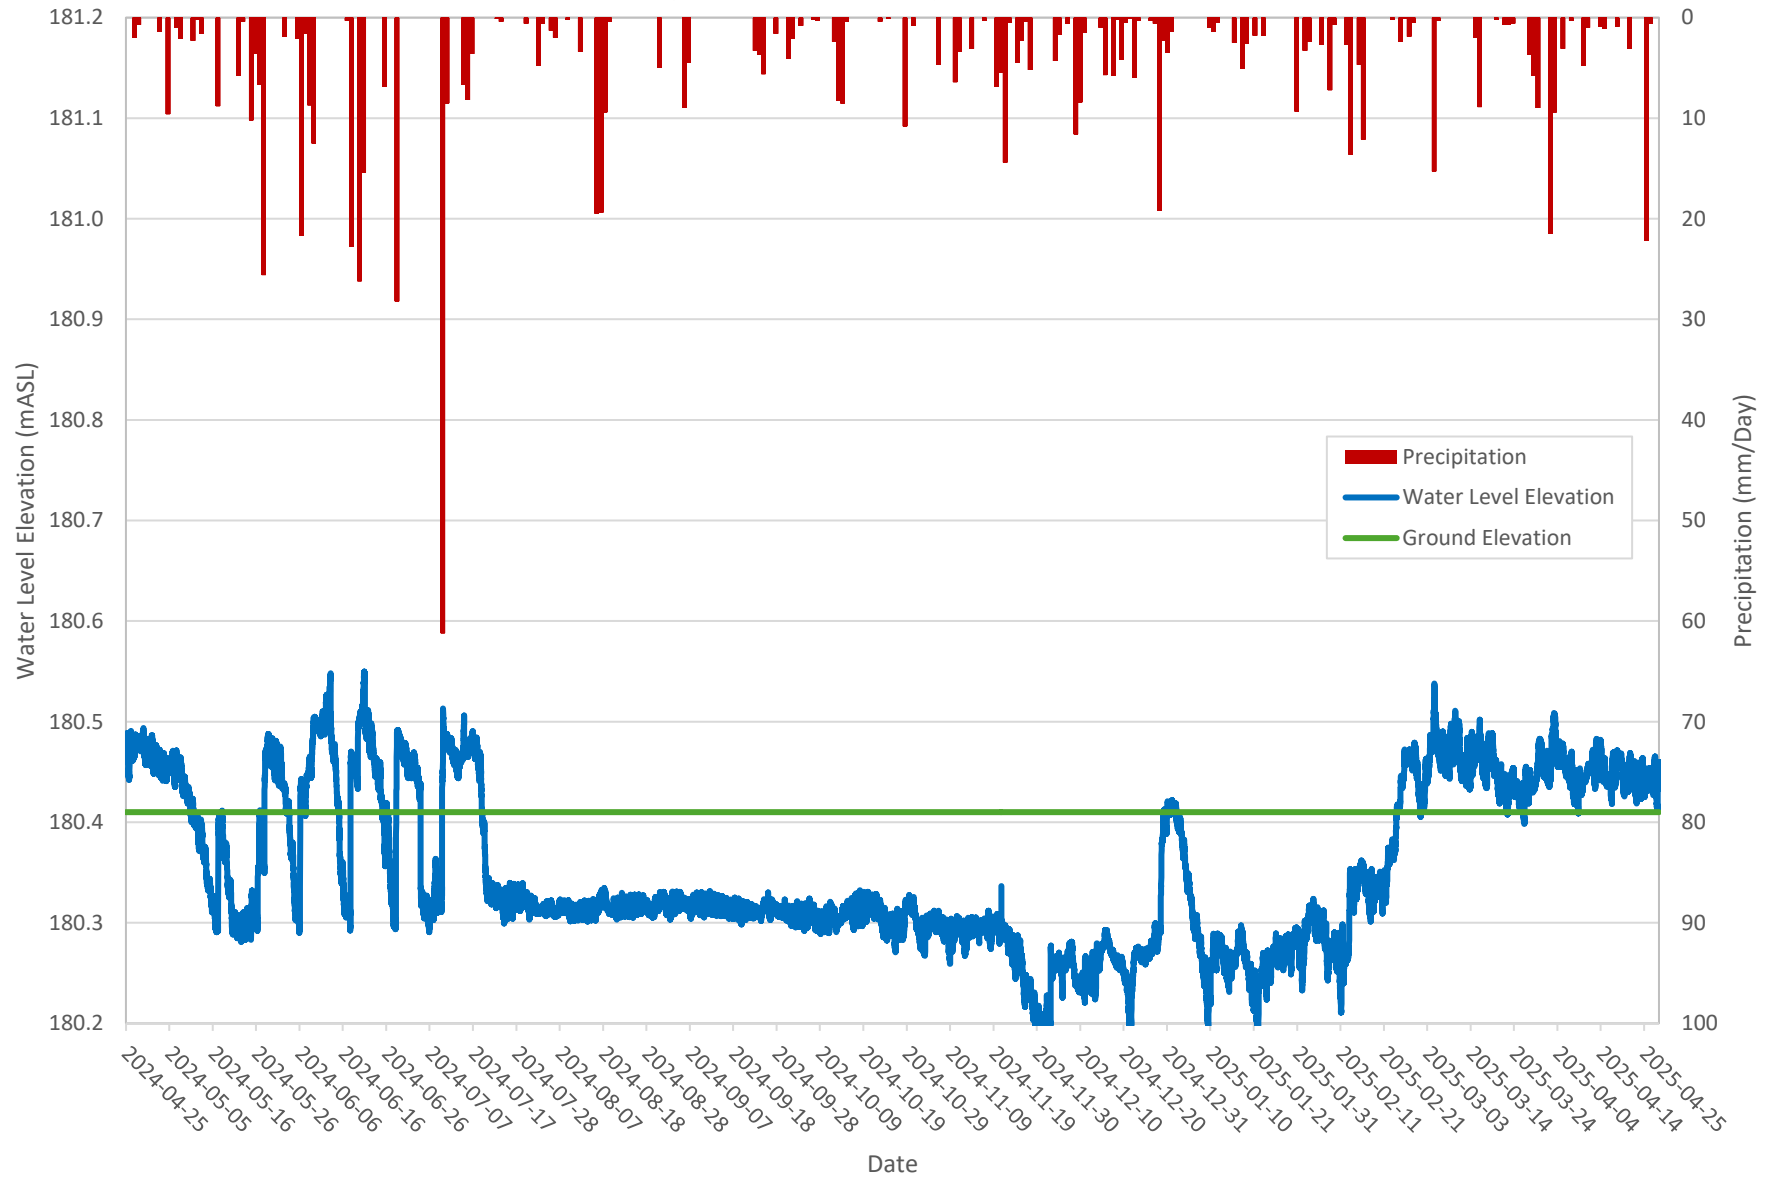
# 7525 Garner Road SG-1 Water Level Elevation and Precipitation from April 25, 2024 to April 28, 2025

At SG-1, surface water levels began to decline shortly after the installation of the datalogger on April 25, 2024, with no sustained surface water (i.e. saturated soil conditions), present after May 10, 2024, until late February 2025. From May 10, 2024, until late February 2025, surface water levels only increased coinciding with precipitation events or snow melt events and then subsequently declined, provided no additional precipitation or melt occurred. For example, on June 29, 2024, a 28 mm precipitation event sustained ponded conditions for five days (Appendix B). As historical daily evaporation rates are estimated to be about 5 mm a day in June, this is in line with the observations made on-site (Schroeter & Associates, 2007) as well as an estimated 9 mm for the initial water abstraction (Section 3.7.1).

Surface water levels in the PSW swamp were sporadic as result of their dependence upon precipitation throughout the early portion of 2024 and displayed sustained conditions only after late February 2025, however, water level depths were less than 0.16 m throughout the one year monitoring period (Appendix B).

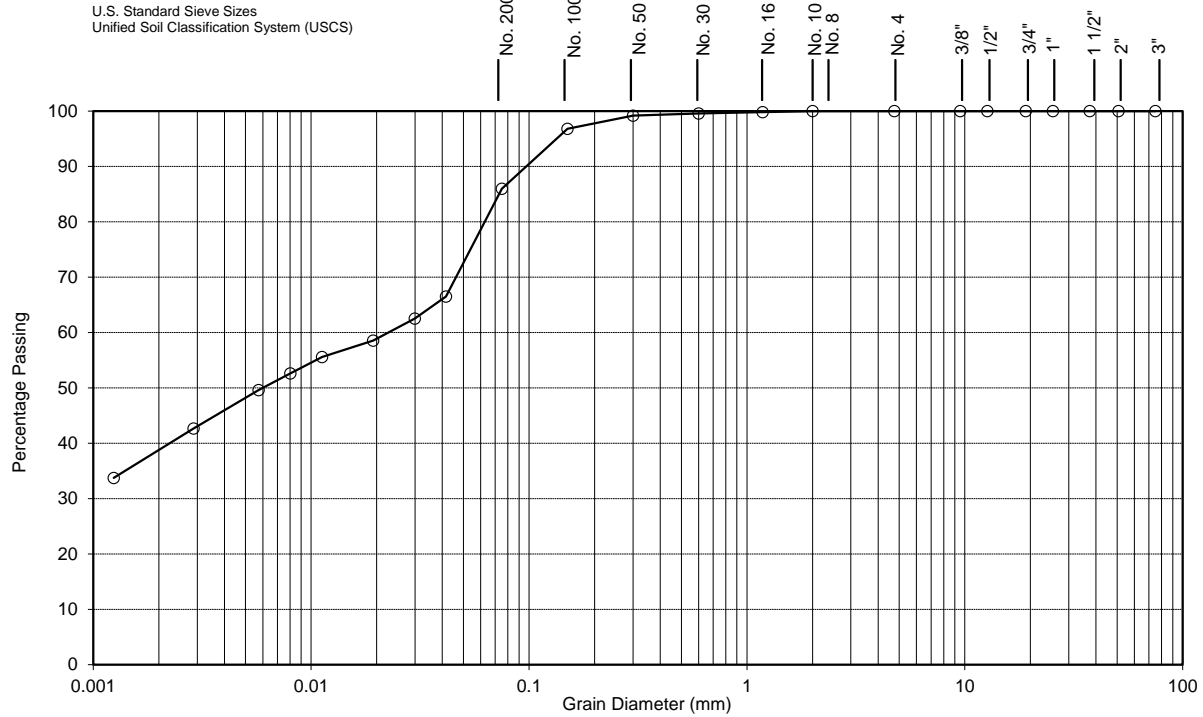
## Mechanical & Hydrometer Analyses

Lab No.: <b>24-163</b>	Notes: <a href="#">Date sample taken: April 25, 2024.</a> <a href="#">Depth: 65 cm -75 cm</a>	
Borehole No.:		
Sample No.: <b>HA-1</b>		
CLAY [%]: <b>39</b>	Soil Description: <b>Brown Silt and Clay w/ some Sand</b> <b>M.L. - Inorganic silts and very fine sands to C.L. - Inorganic clays of low to medium plasticity</b>	
SILT [%]: <b>47</b>		
SAND [%]: <b>14</b>		
GRAVEL [%]: <b>0</b>		
D <sub>10</sub> (Effective Diam. in mm): <b>0.0002</b>	Estimated Infiltration Rate [mm/hr] : <b>&lt; 5</b>	Estimated Permeability, k [cm/s] <b>10<sup>-8</sup></b>
	Coefficient of Uniformity C <sub>u</sub> : <b>110.0</b>	Coefficient of Curvature C <sub>c</sub> : <b>0.2</b>
<b>SOIL-MAT ENGINEERS &amp; CONSULTANTS LTD.</b>		
<b>Madan Site</b>		
<b>April 2024</b>	<b>Grain Size Analysis No. 1</b>	<b>Project No.: SM 230001-T</b>

A soil-sample was collected from the C Horizon (65 to 75 cm below ground surface) within the PSW at hand-auger location HA-1 adjacent SG-1 (Figure 2), suggesting a HSG of C/D (Table 2, Appendix C) as HSG C soils typically have between 20 and 40 percent clay and less than 50 percent sand, and HSG D typically >40% Clay (USDA, 2007).

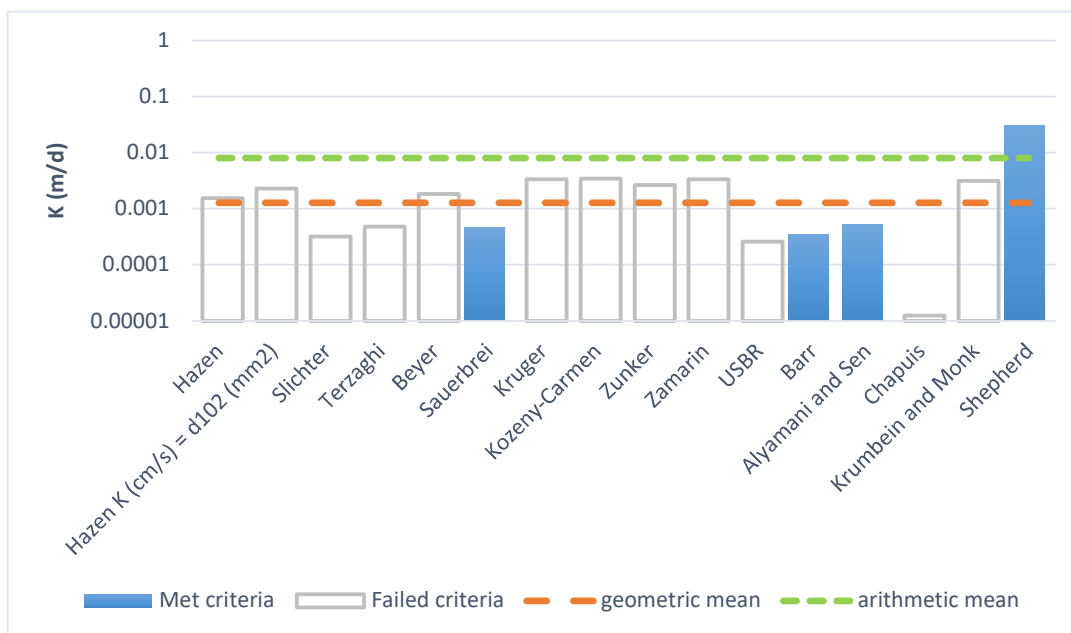
Estimation of Hydraulic Conductivity	cm/s	m/s	m/d	de
Hazen	2.E-06	2.E-08	0.00	
Hazen K (cm/s) = d <sub>10</sub> (mm)	3.E-06	3.E-08	0.00	
Slichter	4.E-07	4.E-09	0.00	
Terzaghi	6.E-07	6.E-09	0.00	
Beyer	2.E-06	2.E-08	0.00	
Sauerbrei	5.E-07	5.E-09	0.00	
Kruger	4.E-06	4.E-08	0.00	
Kozeny-Carmen	4.E-06	4.E-08	0.00	
Zunker	3.E-06	3.E-08	0.00	
Zamarin	4.E-06	4.E-08	0.00	
USBR	3.E-07	3.E-09	0.00	
Barr	4.E-07	4.E-09	0.00	
Alyamani and Sen	6.E-07	6.E-09	0.00	
Chapuis	1.E-08	1.E-10	0.00	
Krumbein and Monk	4.E-06	4.E-08	0.00	
Shepherd	4.E-05	4.E-07	0.03	
geometric mean	1.E-06	1.E-08	0.00	
arithmetic mean	9.E-06	9.E-08	0.01

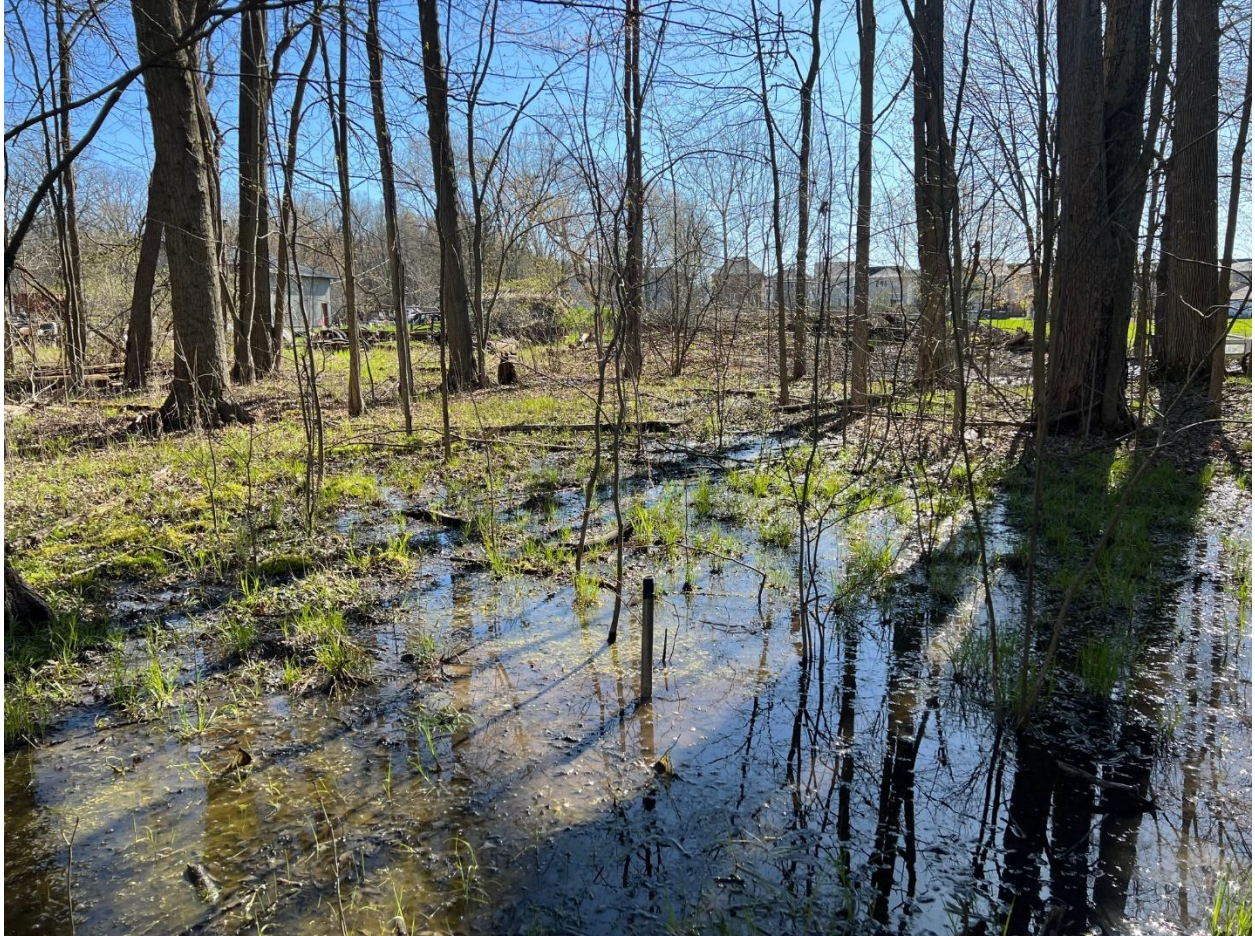
Photograph 1: Photograph taken facing east on the property boundary displaying the staff gauge, ponded wetland area while facing towards Garner Rd. The elevated ground bordering the wetland can also be seen. Photograph taken April 25, 2024.

During Site visits by Terra-Dynamics staff, it was noted that along the eastern boundary of the wetland there was small slope or berm along the wetland boundary. The berm does not allow for an outflow of the wetland to the rest of the Site, and approximately denotes the edge of the woodlot limit as surveyed by MMP (2024).

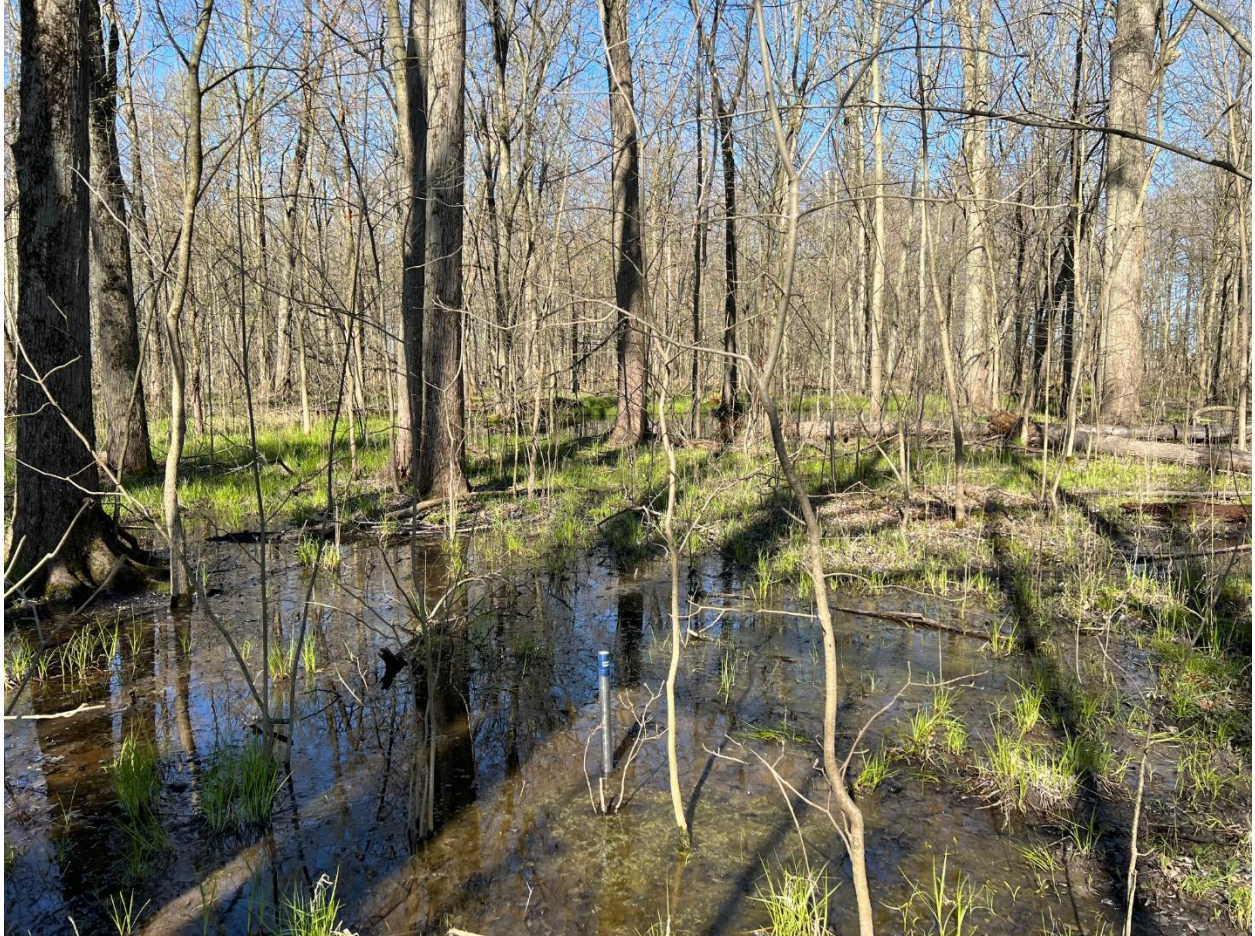
Photograph 2: The photograph was taken facing west displaying the staff gauge and the ponded wetland area, additional pockets of ponded water can be seen in the background. Photograph taken April 25, 2024.

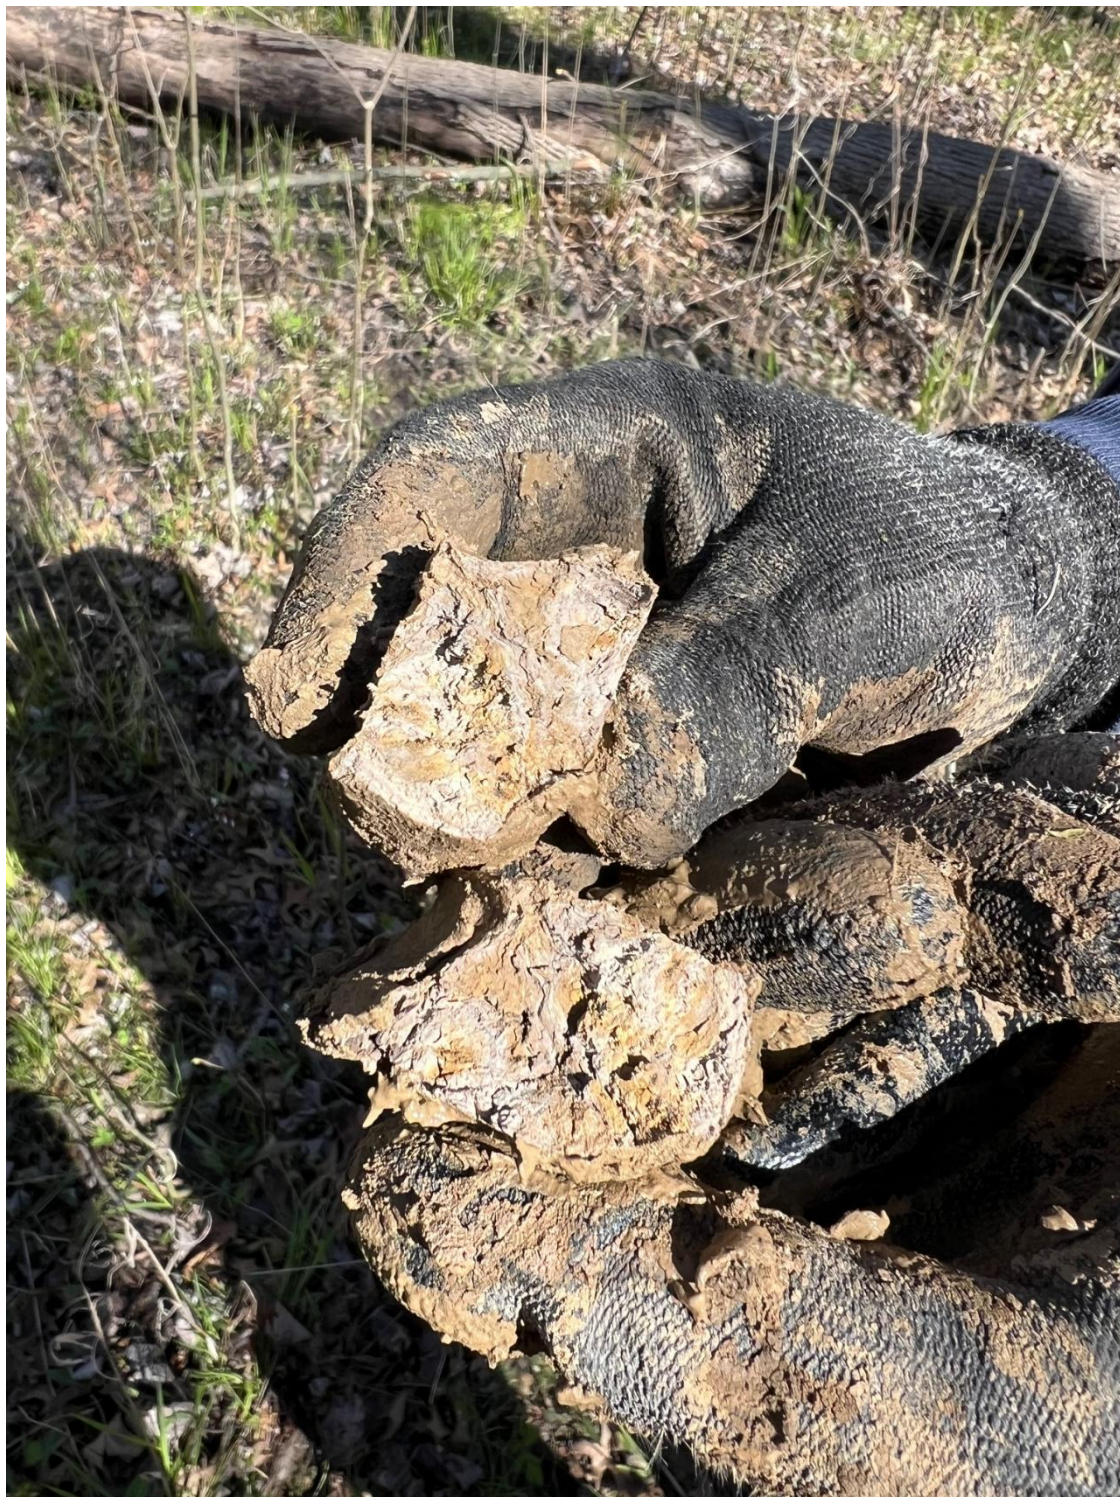
Photograph 3: The photograph displays the soil from 65-75cm below ground surface that was sampled and the mottling. Photograph taken April 25, 2024.

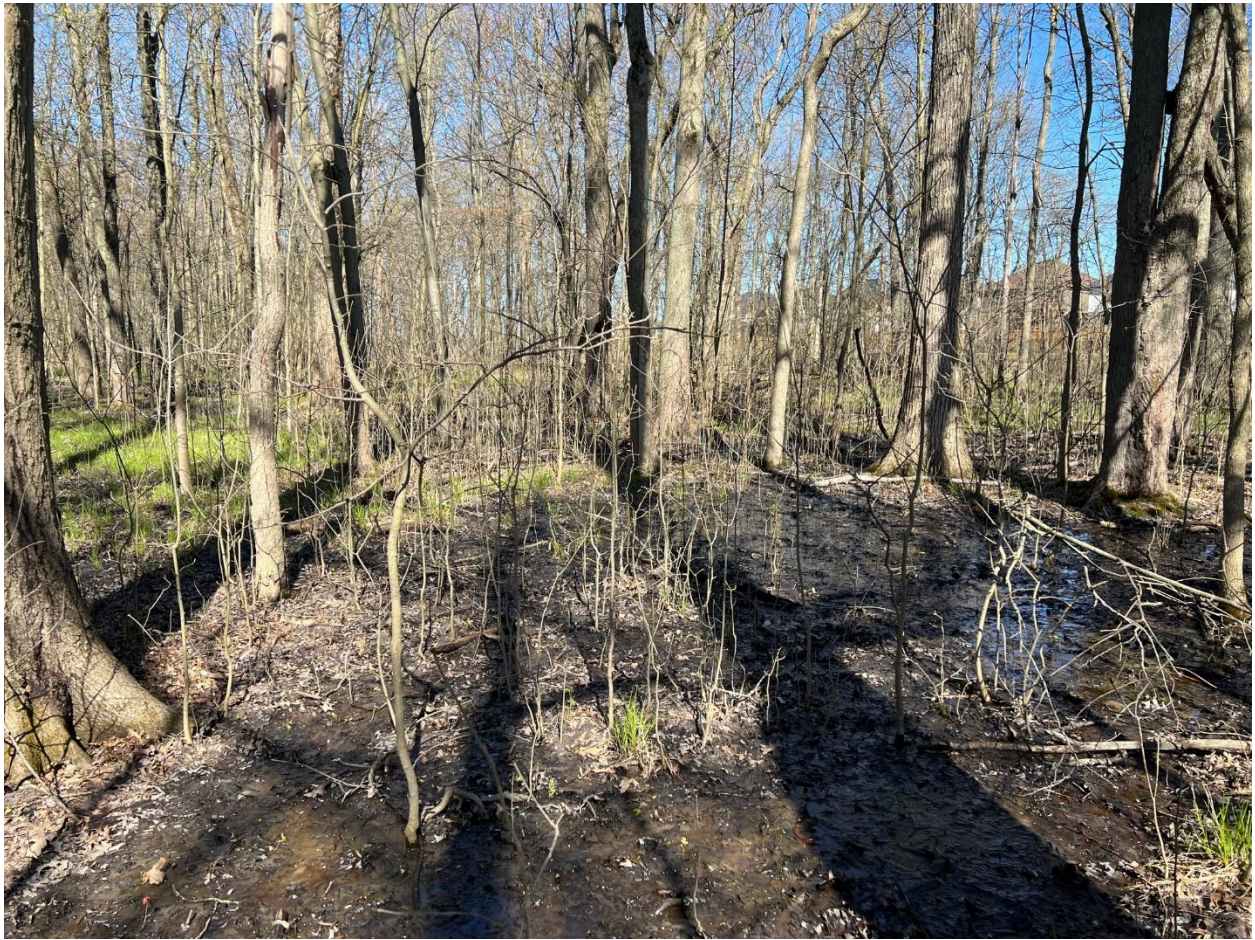
Photograph 4: The photograph was taken facing northwest displaying the more northern portion of the wetland within the client's property boundary. Photograph taken April 25, 2024.

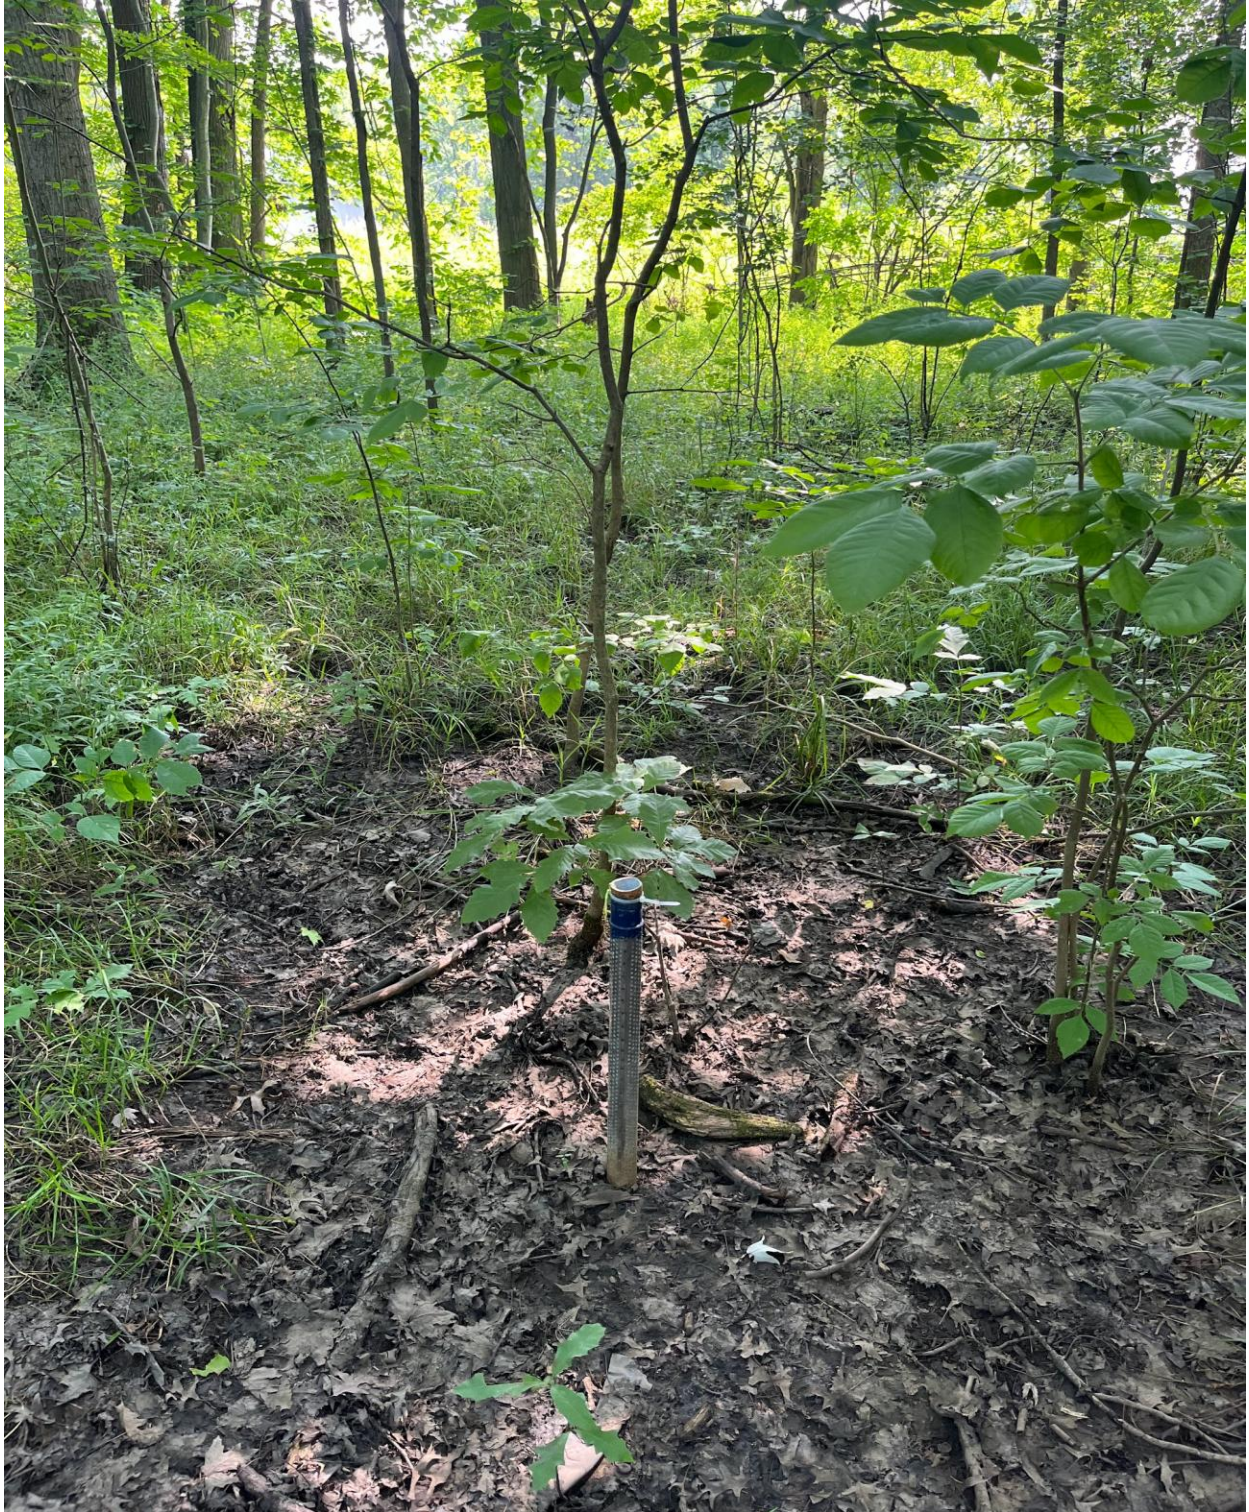
Photograph 5: Photograph taken facing east on the property boundary displaying the staff gauge during dry conditions, while facing towards Garner Rd. Photograph taken August 1, 2024.

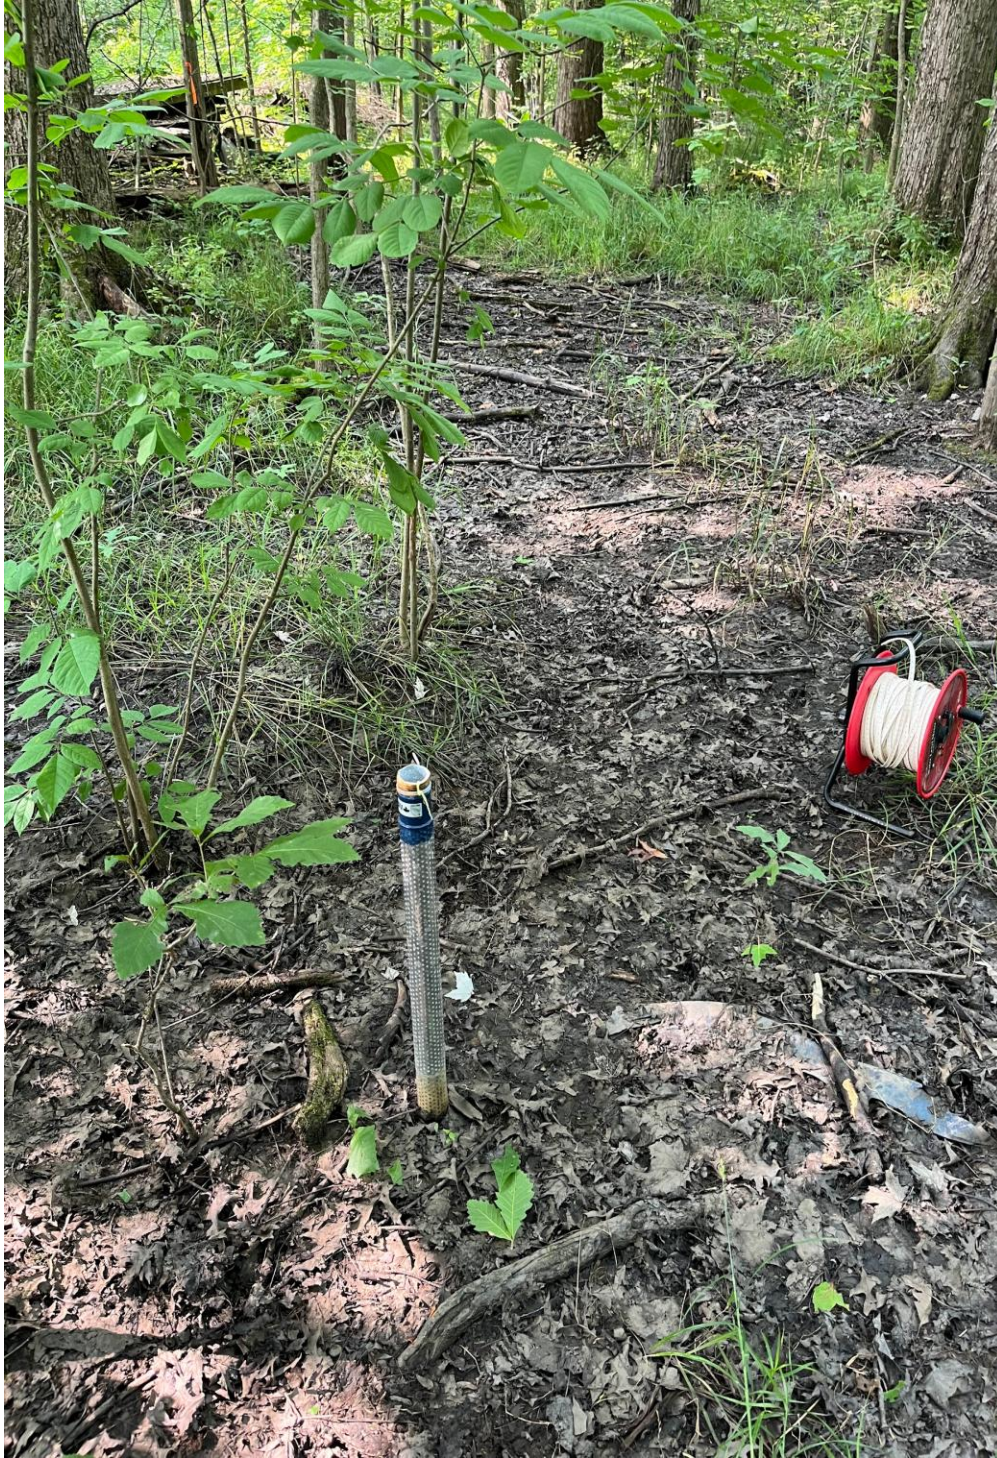
Photograph 6: Photograph taken facing south on the property boundary displaying the staff gauge during dry conditions. Photograph taken August 1, 2024.

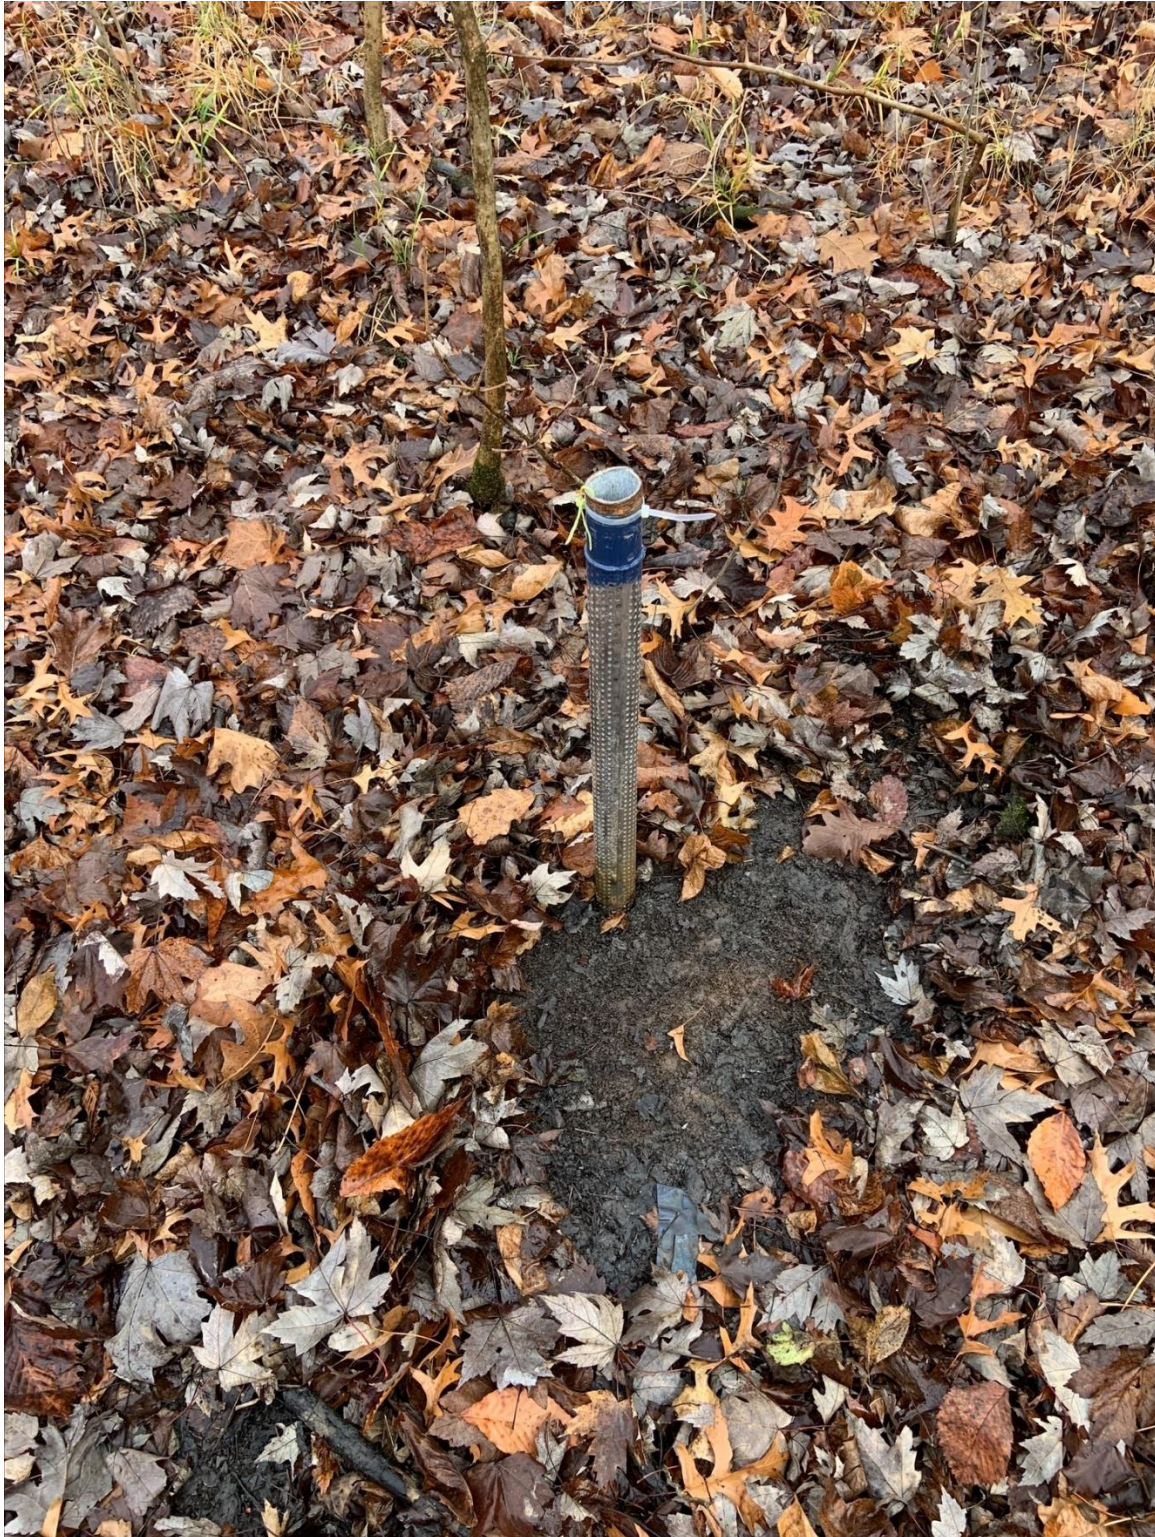
Photograph 7: Photograph taken facing south on the property boundary displaying the staff gauge during dry conditions. Photograph taken November 21, 2024.

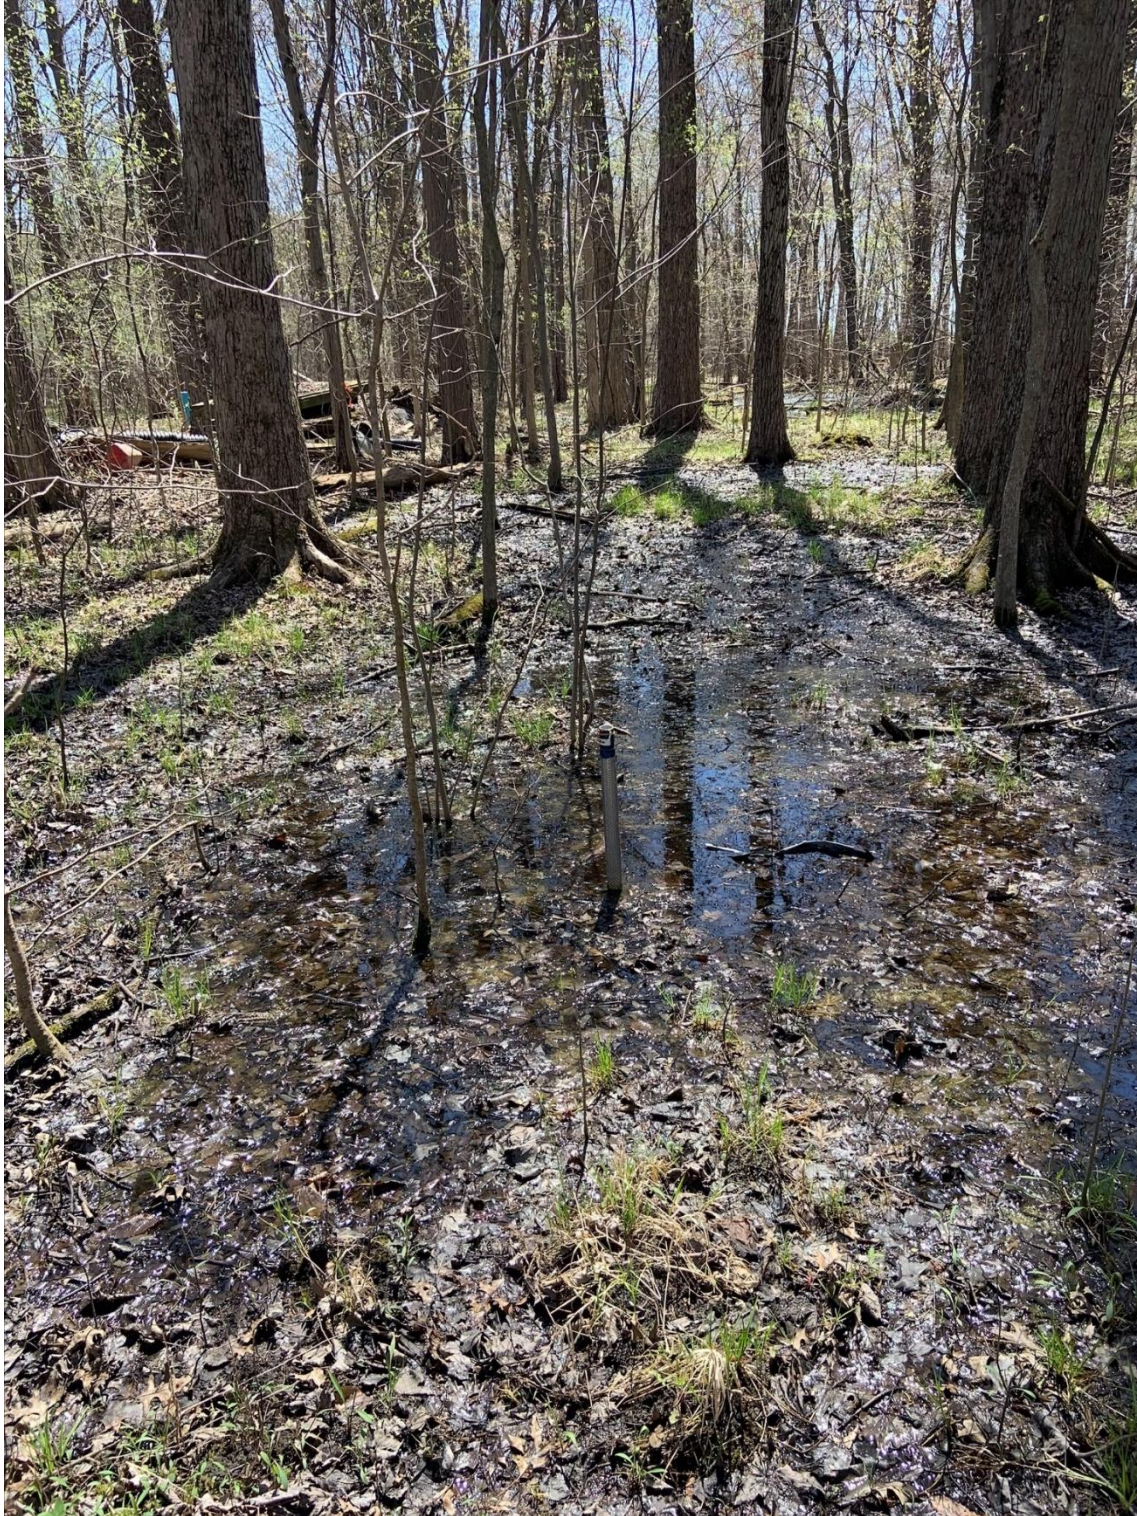
Photograph 8: Photograph taken facing south on the property boundary displaying the staff gauge during wet conditions. Photograph taken April 28, 2025.
