6009 to 6017 Valley Way, Niagara Falls, ON
Phase One Environmental Site Assessment

6009 to 6017 Valley Way
Niagara Falls, ON
L2E 1X9

Date: May 13, 2025
NSSL File No.: NS2560-01

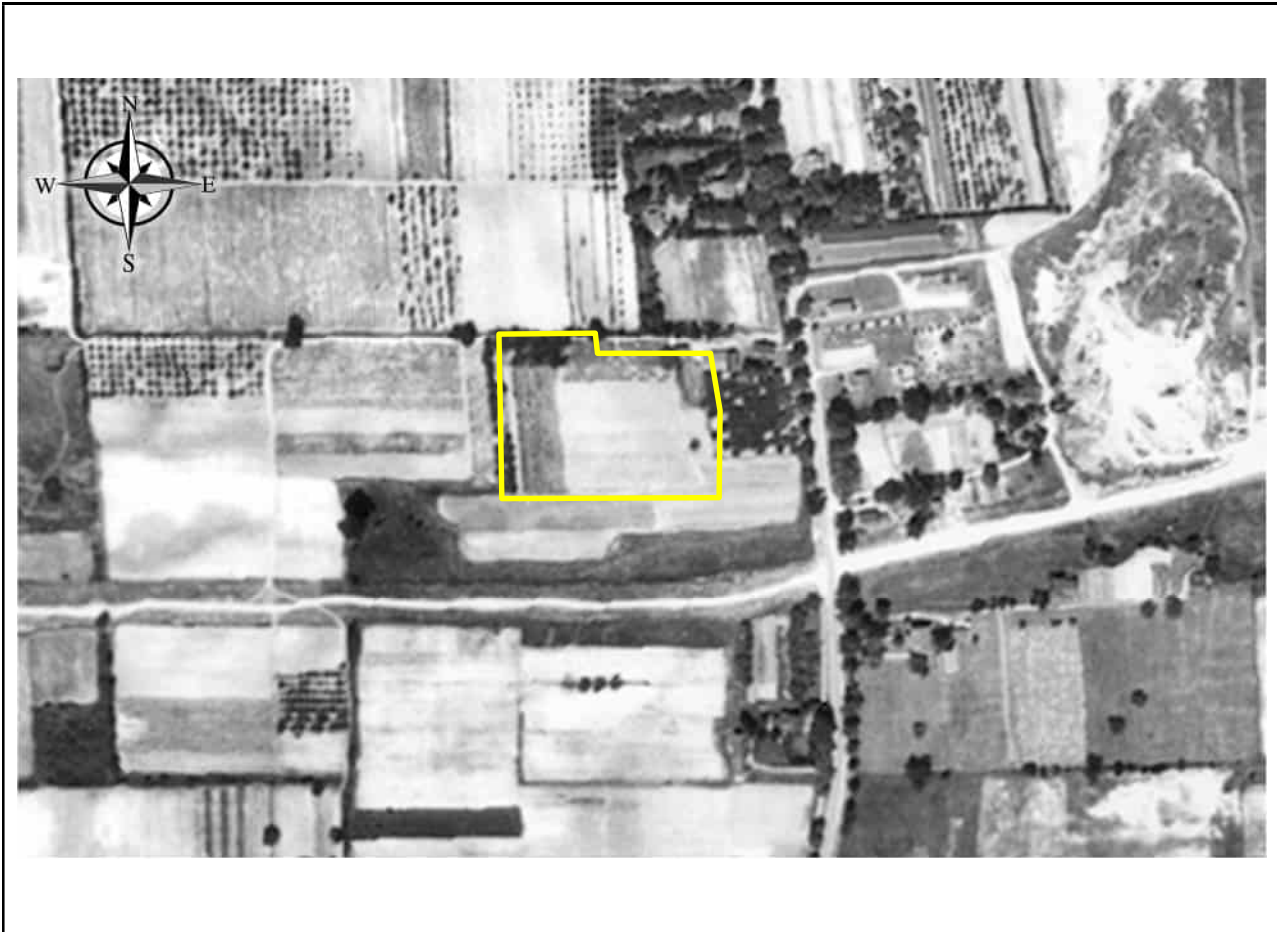
Photograph No.:	1	Year:	1934
Source :	Ministry of Natural Resources Maxar

Date	Phase One Site	Study Area
1934	The Site is an agricultural lot with no structures. Two access roadways are noted along the northern and western property boundary.	The surrounding area is agricultural lots, with sparse development, likely for farming and residential purposes. Historic roadways are noted; however, not similar to present day.
1954	The western half is utilized as an orchard, and row crops along the eastern property boundary. An access road is noted along the northern boundary.	The orchard on-site extends to the western boundary of the study area. The southern and eastern portion have developed into a residential suburb. Valley Way and Portage Road are evident.
1965	No significant changes were in the 1965 aerial view. The roadway development, to the north, appears to be evident on Site.	A suburb has been constructed to the north, and dwellings have been developed throughout the study area. Commercial buildings are evident at the intersection of Valley Way and Portage Road.

During a review of the historical aerial photographs, NSSL identified a historical orchard in the 1934 to 1965 aerial photographs. The orchard was noted to cover the majority of the Site, however there wasn't any evidence of historical farming equipment stored or associated farming structures noted on-site. Farming practices were predominant in the area until the early 1960s, when surrounding residential development commenced. The potential application of pesticides to orchards and surrounding crops for

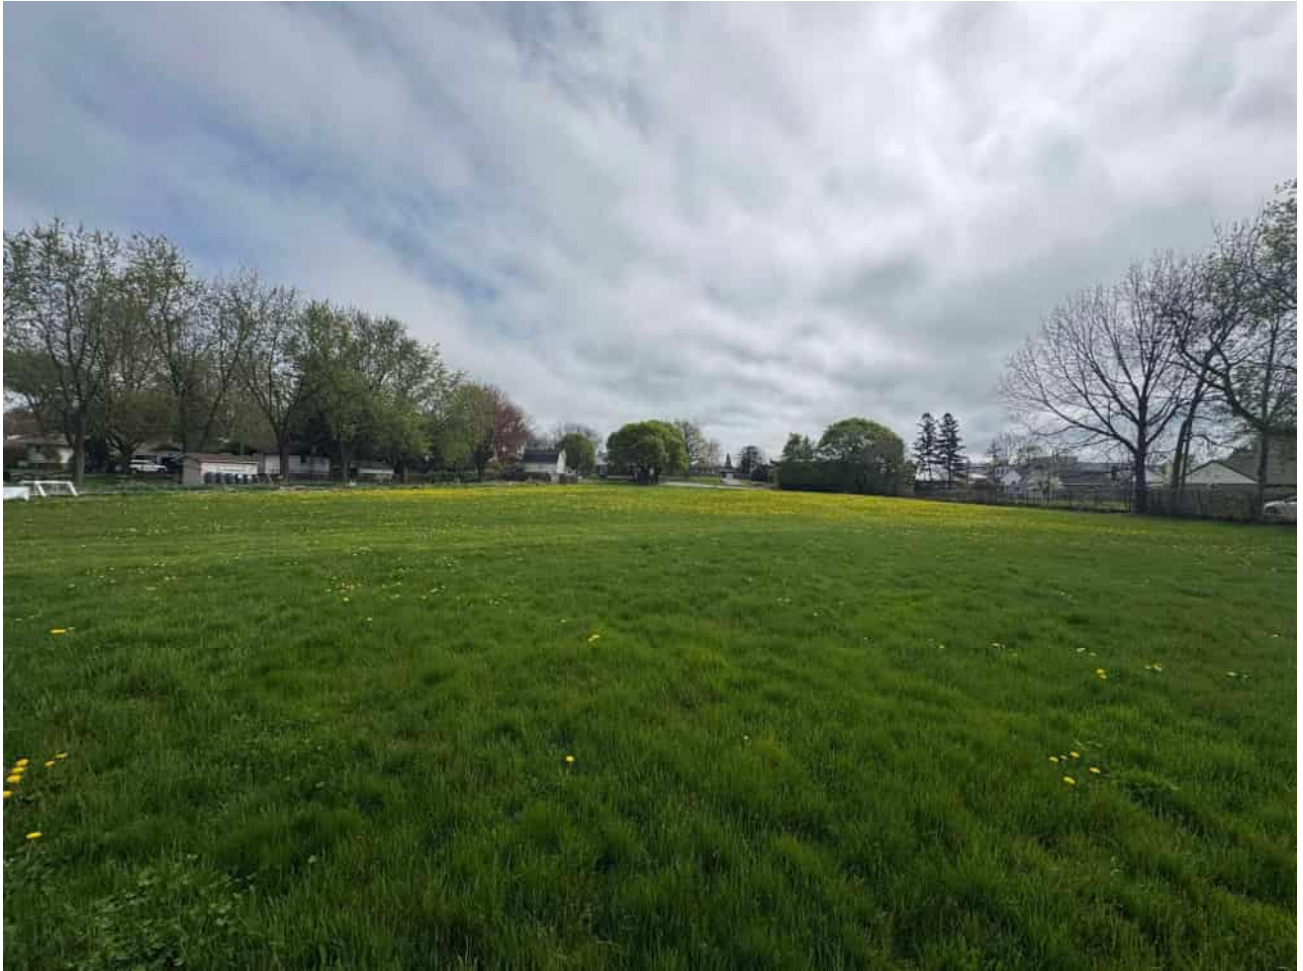
Photograph 1: Western to central portion of the Site is depicted as a vacant lot with no structures on-site and a gentle slope towards the southeast.

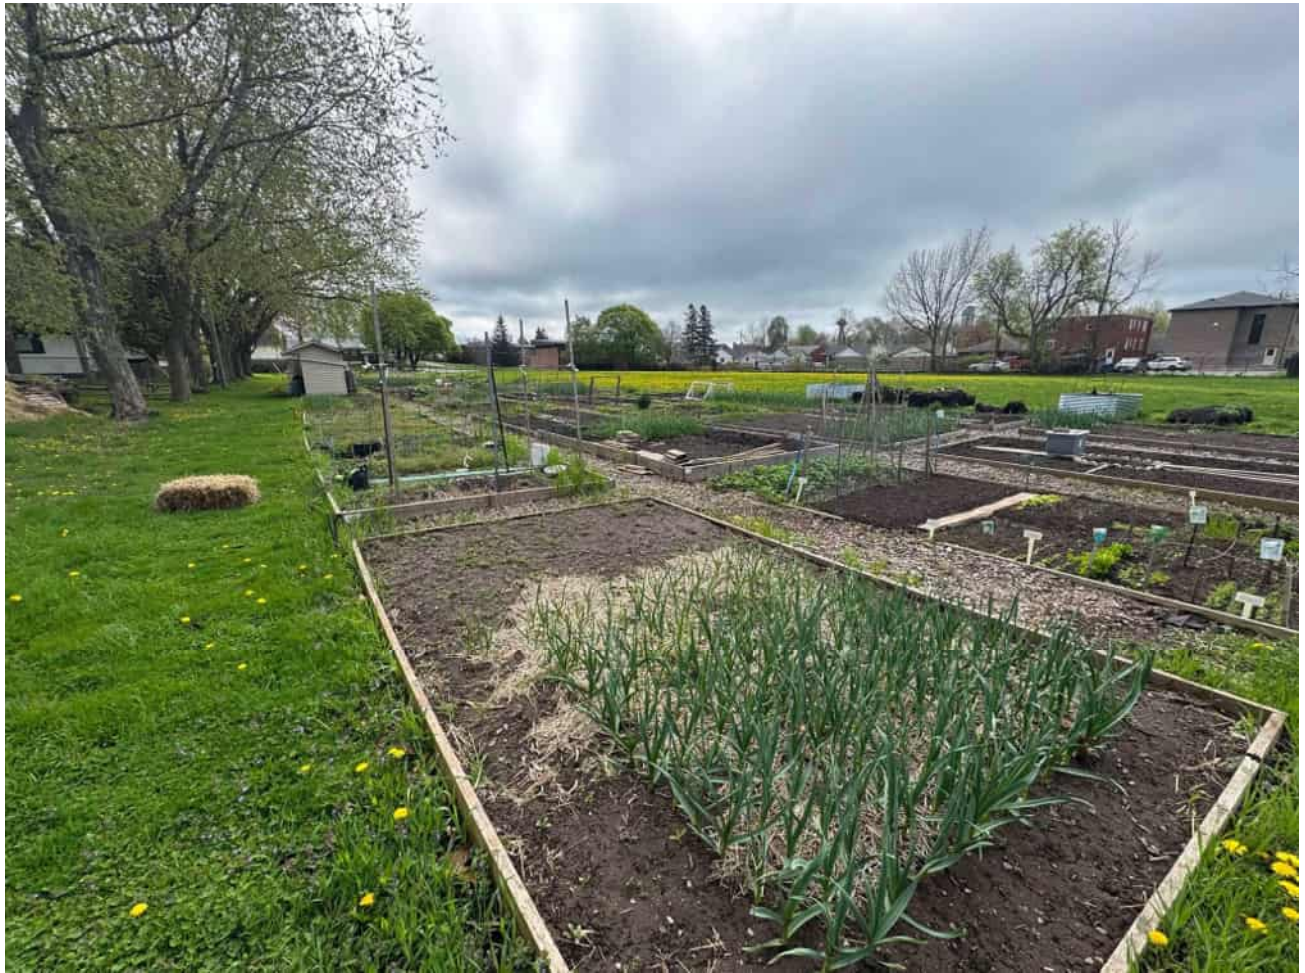
Photograph 3: Northern section of the Site is currently being used for recreational gardening. A small garden shed is noted within the central area of the garden beds.
